PROPOSED DEVELOPMENT AT BOHERBOY, SAGGART, CO. DUBLIN

Road Safety Audit Stage 1/2

KELLAND HOMES LIMITED (KHL)

DECEMBER 2025

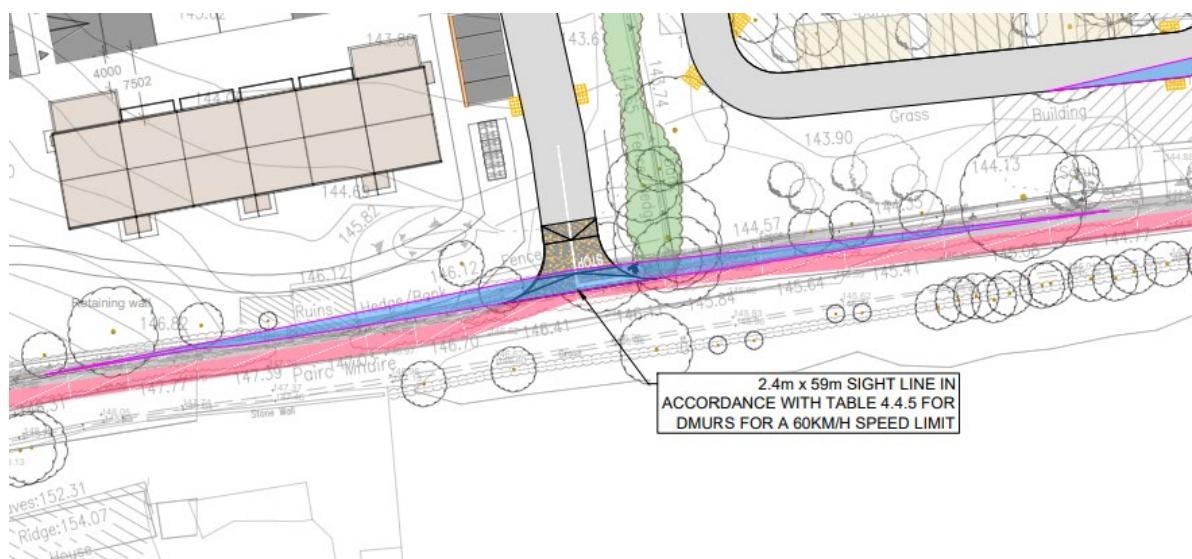
Figure 2.1 – Visibility Splays at Boherboy Access

Location: Boherboy Access

Visibility splays from the proposed access onto Boherboy Road may be obstructed by existing trees, and roadside boundaries either side of the access. Road safety risk is increased in situations where inter-visibility between drivers turning out of an access and drivers approaching on the mainline is restricted. Lack of adequate visibility may increase the likelihood of a collision at the access.

Recommendation: Ensure that adequate visibility splays are be provided at the access and remove all obstructions within the visibility splays.

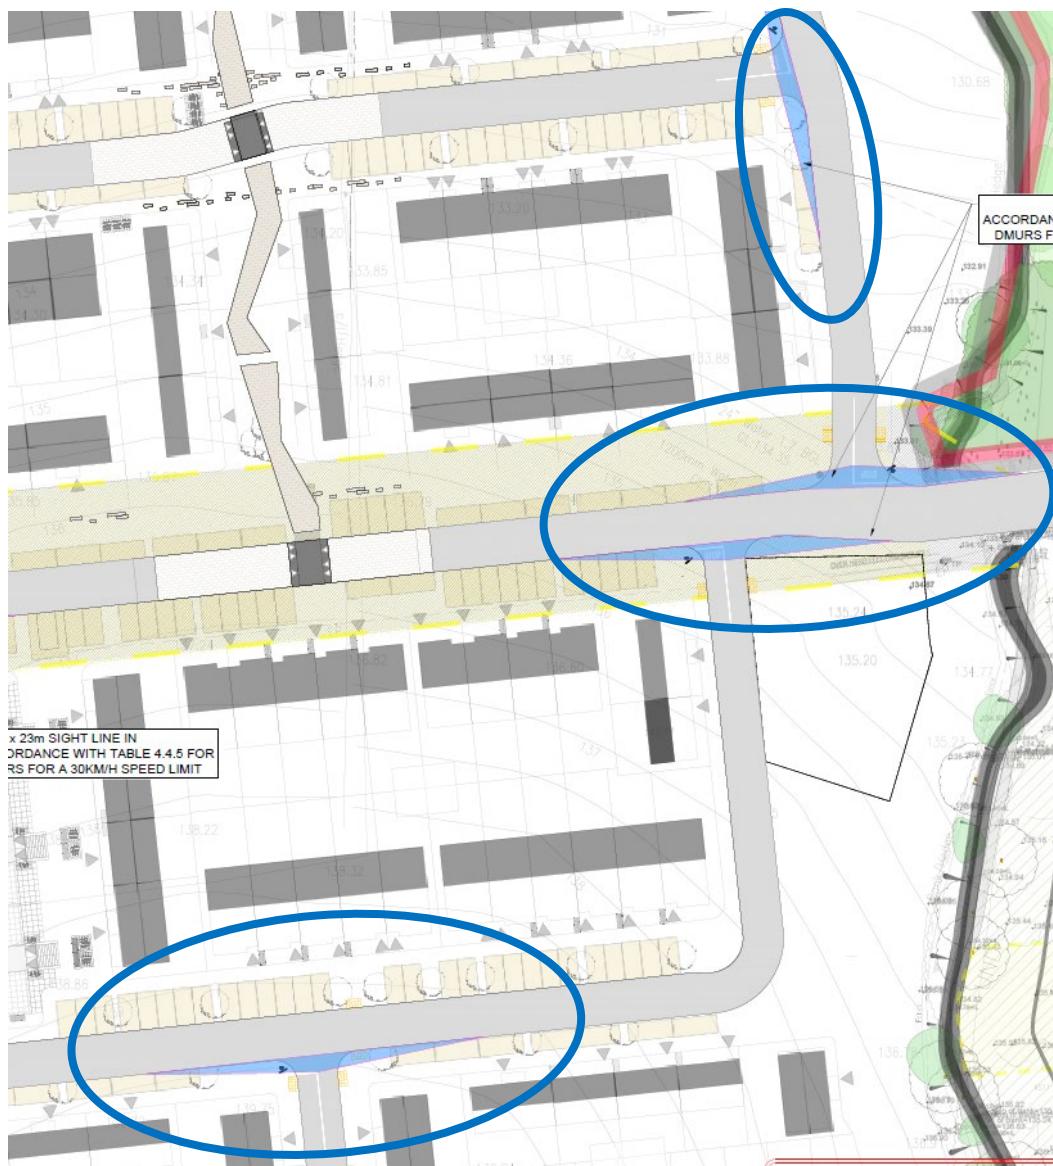
Figure 2.2 –Visibility Splays at internal Junctions

Location: Internal Junctions

Visibility splays at a number of proposed internal junctions may be obstructed by vehicles parked in the adjacent car parking spaces including but not limited to the locations shown in the image below. Road safety risk is increased in situations where inter-visibility between drivers turning out of an access and drivers approaching on the mainline is restricted. Lack of adequate visibility may increase the likelihood of a collision at these internal junctions.

Recommendation: Ensure that adequate visibility splays are be provided at the accesses and remove all obstructions within the visibility splays.

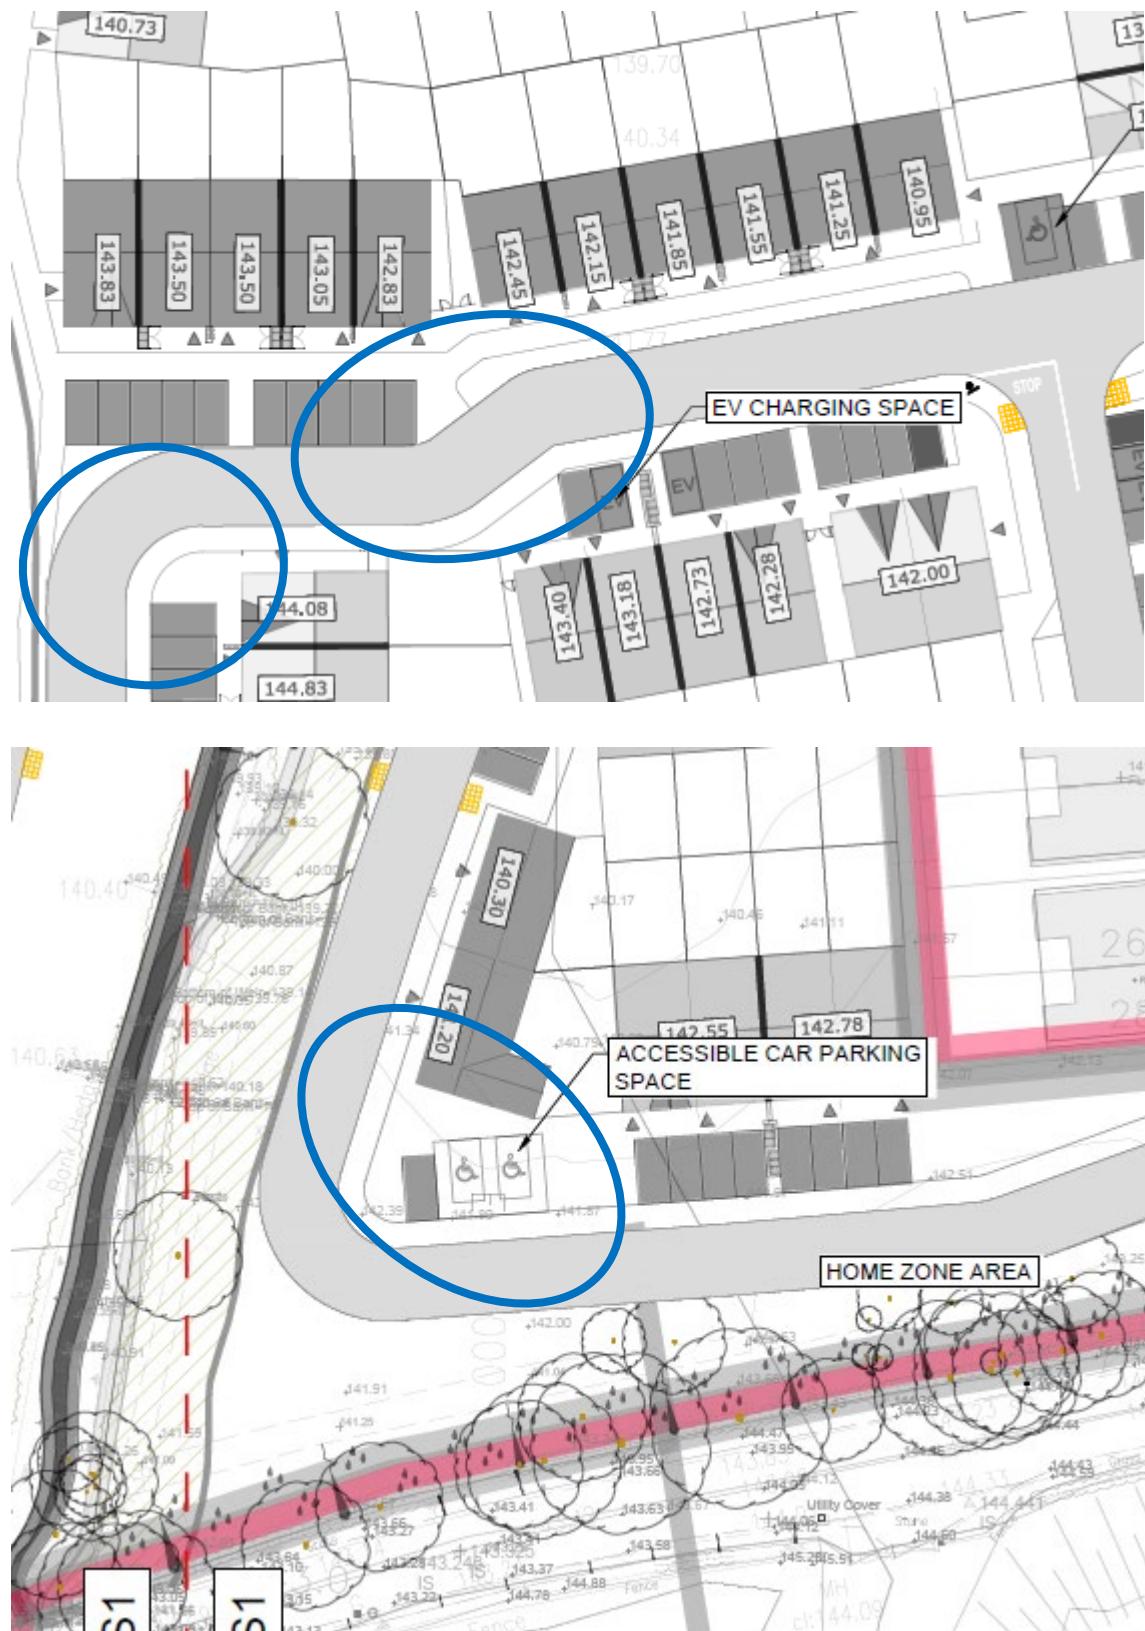
Figure 2.3 – Compromised Stopping Sight Distance

Location: Various

Two opposing vehicles may have difficulty in passing one another at low radius bends within the proposed development including but not limited to the locations shown in the images below. In addition, stopping sight distance may be restricted by a landscaping and parked vehicles on the inside of bends. A lack of appropriate stopping sight distance may contribute to a collision at these locations.

Recommendation: Ensure that two opposing vehicles can pass one another on all low radius bends and ensure that adequate stopping sight distance is available at all locations.

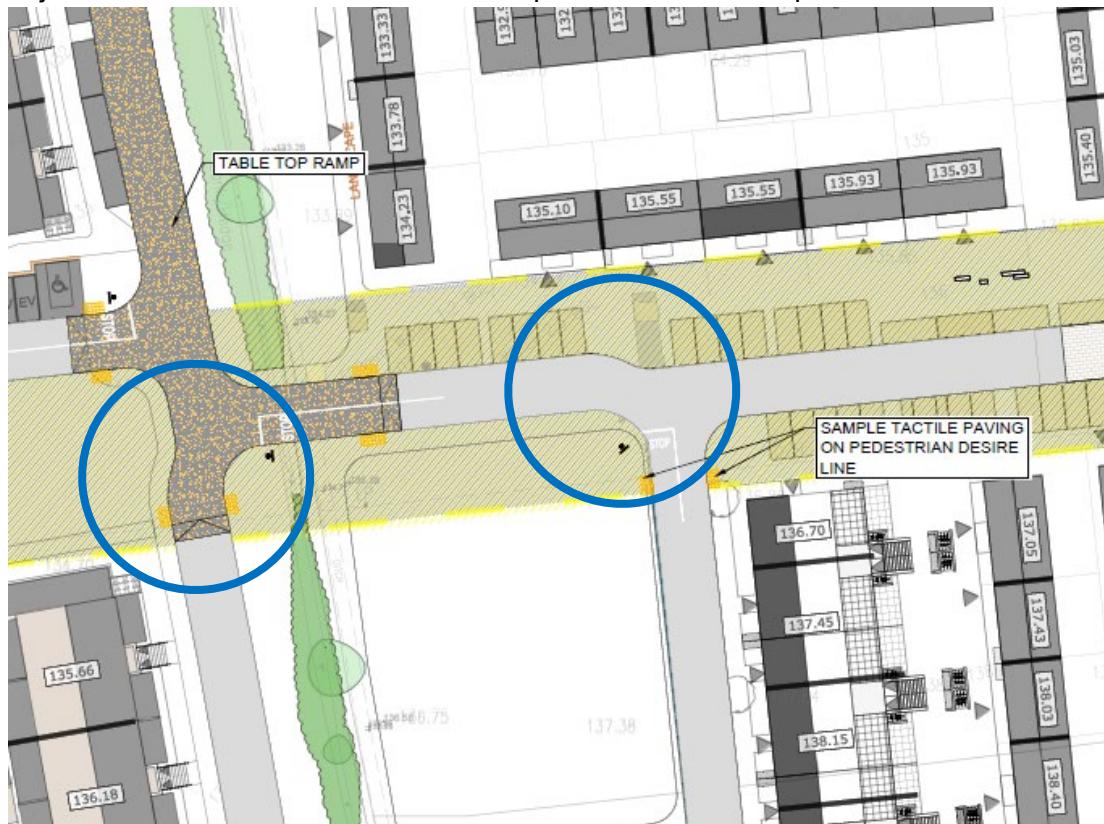
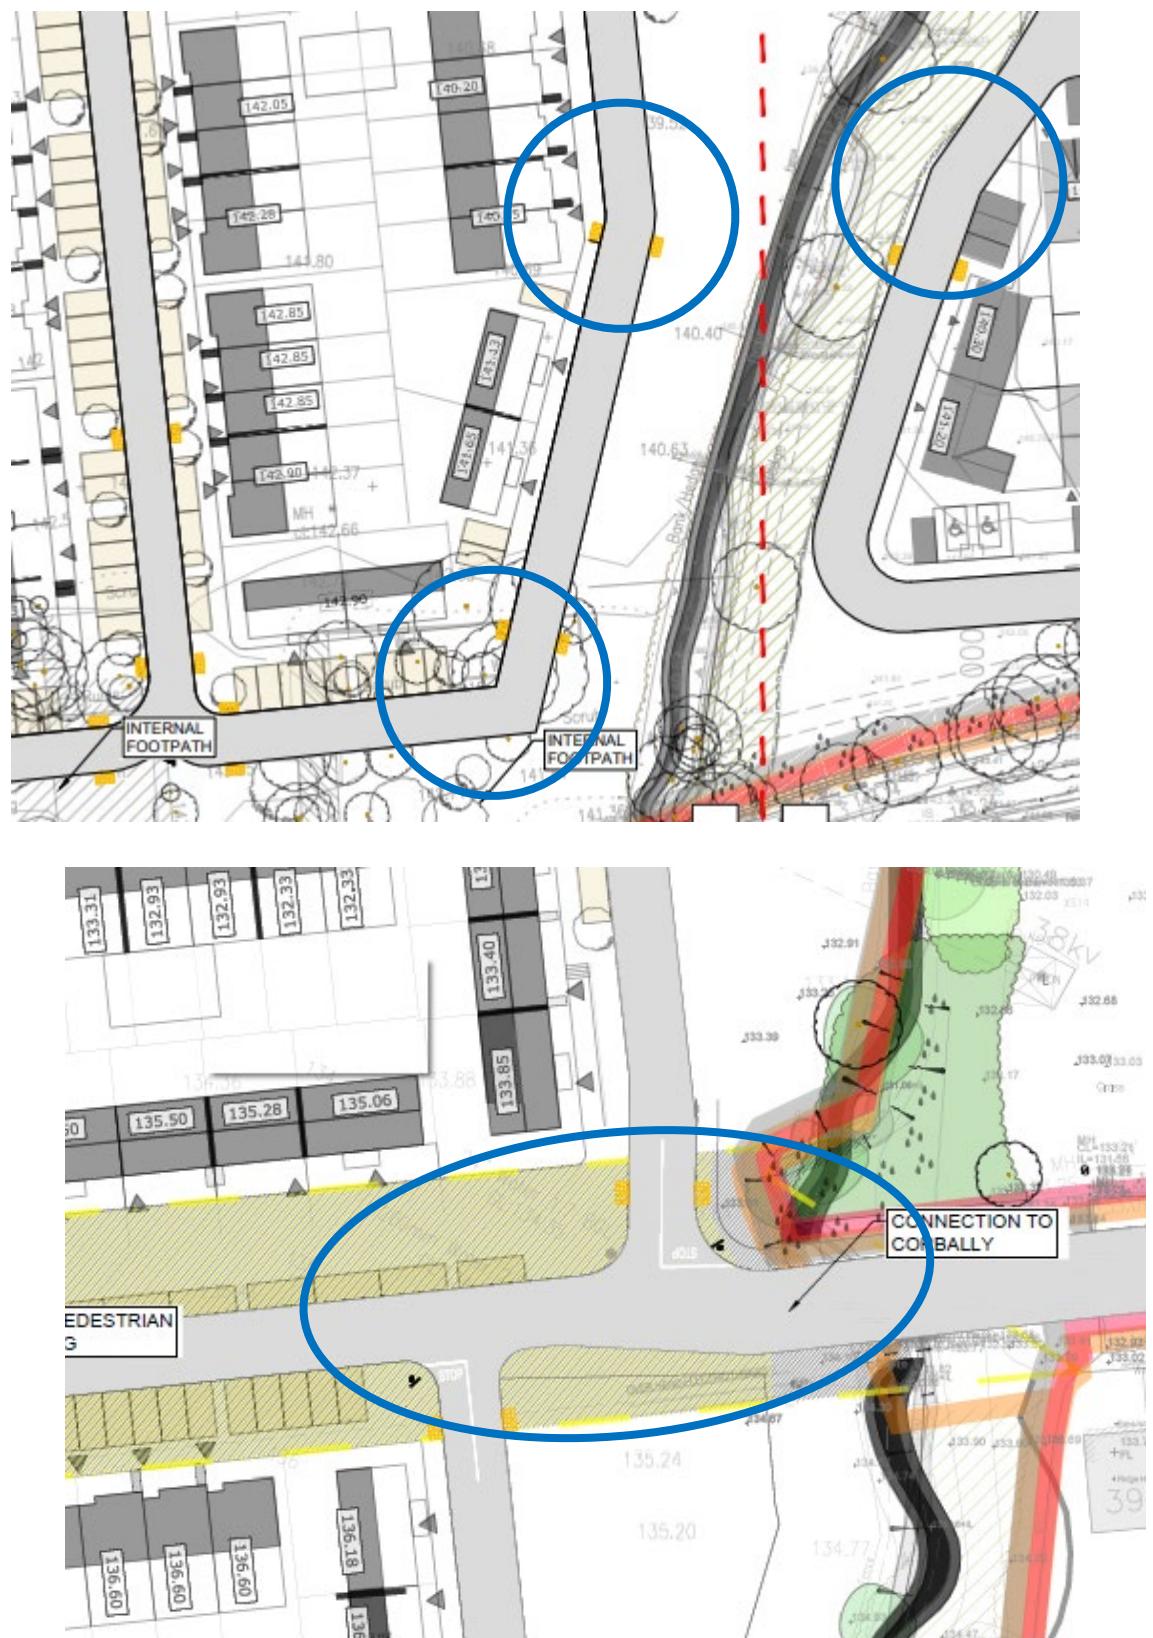
Figure 2.4 – Deflection in Carriageway

2. 4 Problem: Horizontal Alignment**Location:** Various

At various locations there are deflections in carriageway geometry and narrowing of carriageways including but not limited to those shown in the images below. This may give rise to an increased risk of sideswipe or head-on type collisions, especially in close proximity to junctions where there is an increased presence of conflict points.

Recommendation: Ensure that the horizontal alignment of the internal access roads are in line with the minimum curve radii in accordance with Table 4.3 of the DMURS.

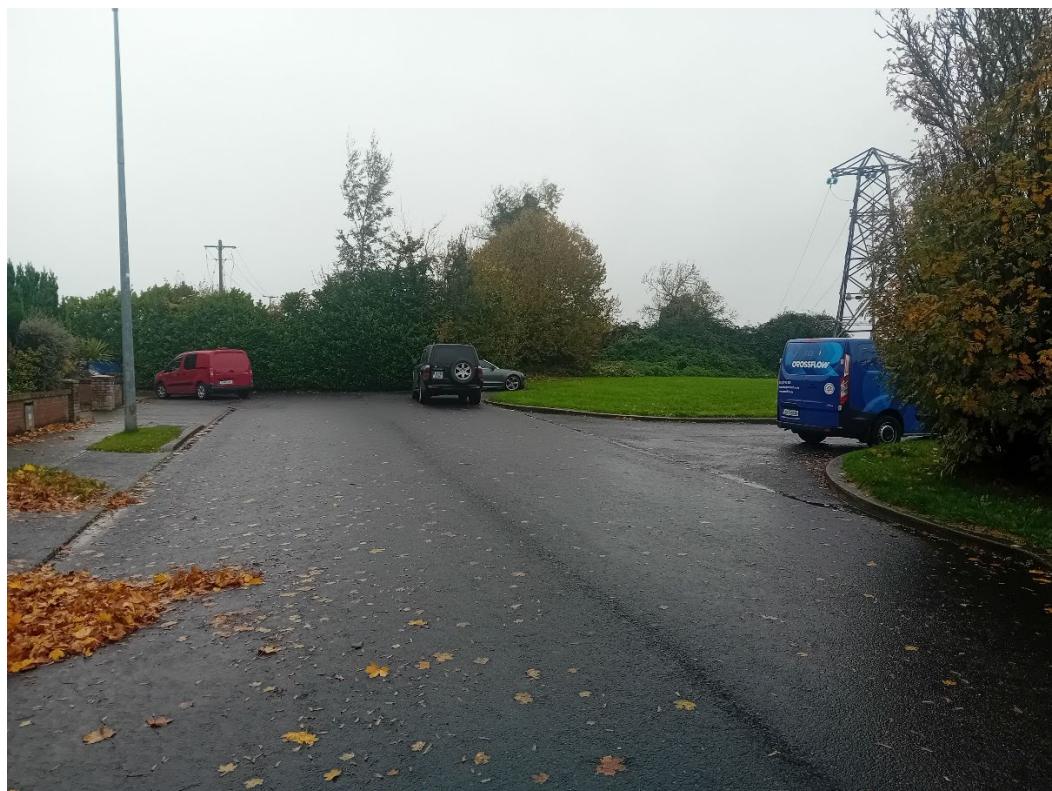
Figure 2.5 – Junction Priority

2. 5 Problem: Undefined priority at junction**Location:** Internal junction within Corbally Heath

The road within Corbally Heath to which the proposed development is to connect is a short cul-de-sac that connects to the main spine road within Corbally Heath at a three-arm simple junction. Priority is undefined at that junction, but that does not cause a problem at present because it is clear to drivers that the short cul-de-sac is the minor arm. However, the intended connection of the new estate to this cul-de-sac arm may change the traffic balance at the junction and it may not be clear which arm has priority. This may increase collision risk for users of the junction.

Recommendation: Mark a STOP line and text on the Corbally Lane arm of the three-armed junction.

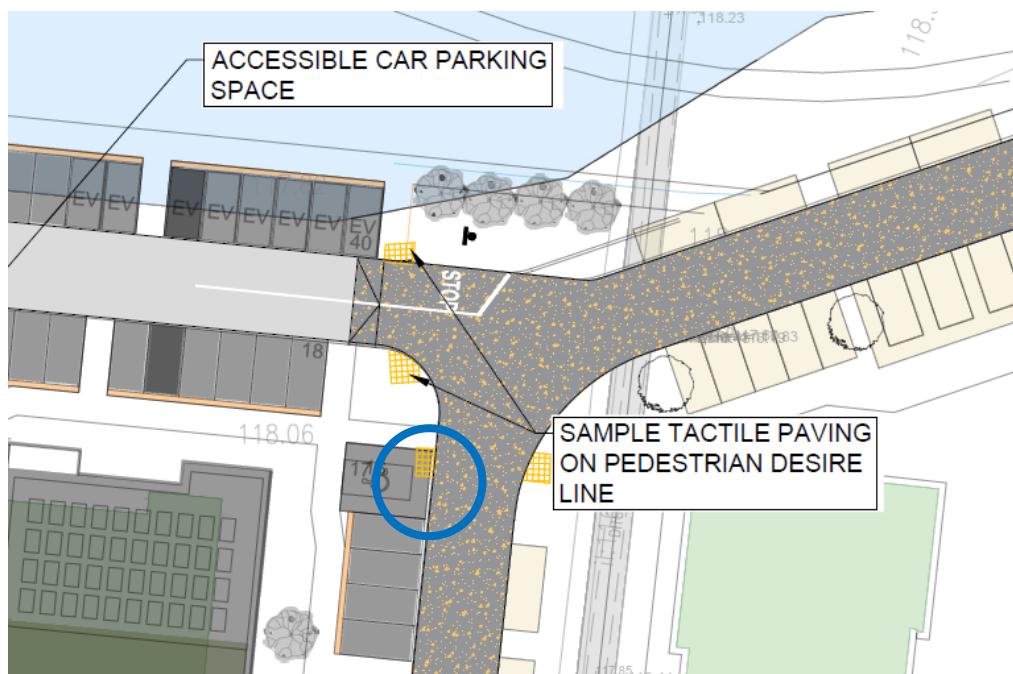
Figure 2.6 – Tactile paving location

2. 10 Problem: Cars Reversing onto Pedestrian Crossings**Location:** Various

At a number of locations, vehicles turning to and from parking spaces will likely traverse tactile paving at pedestrian crossings. Damaged or broken tactile paving may lead to trip hazards for pedestrians.

Recommendation: Relocate pedestrian crossings away from locations where vehicles will be turning to and from parking spaces.

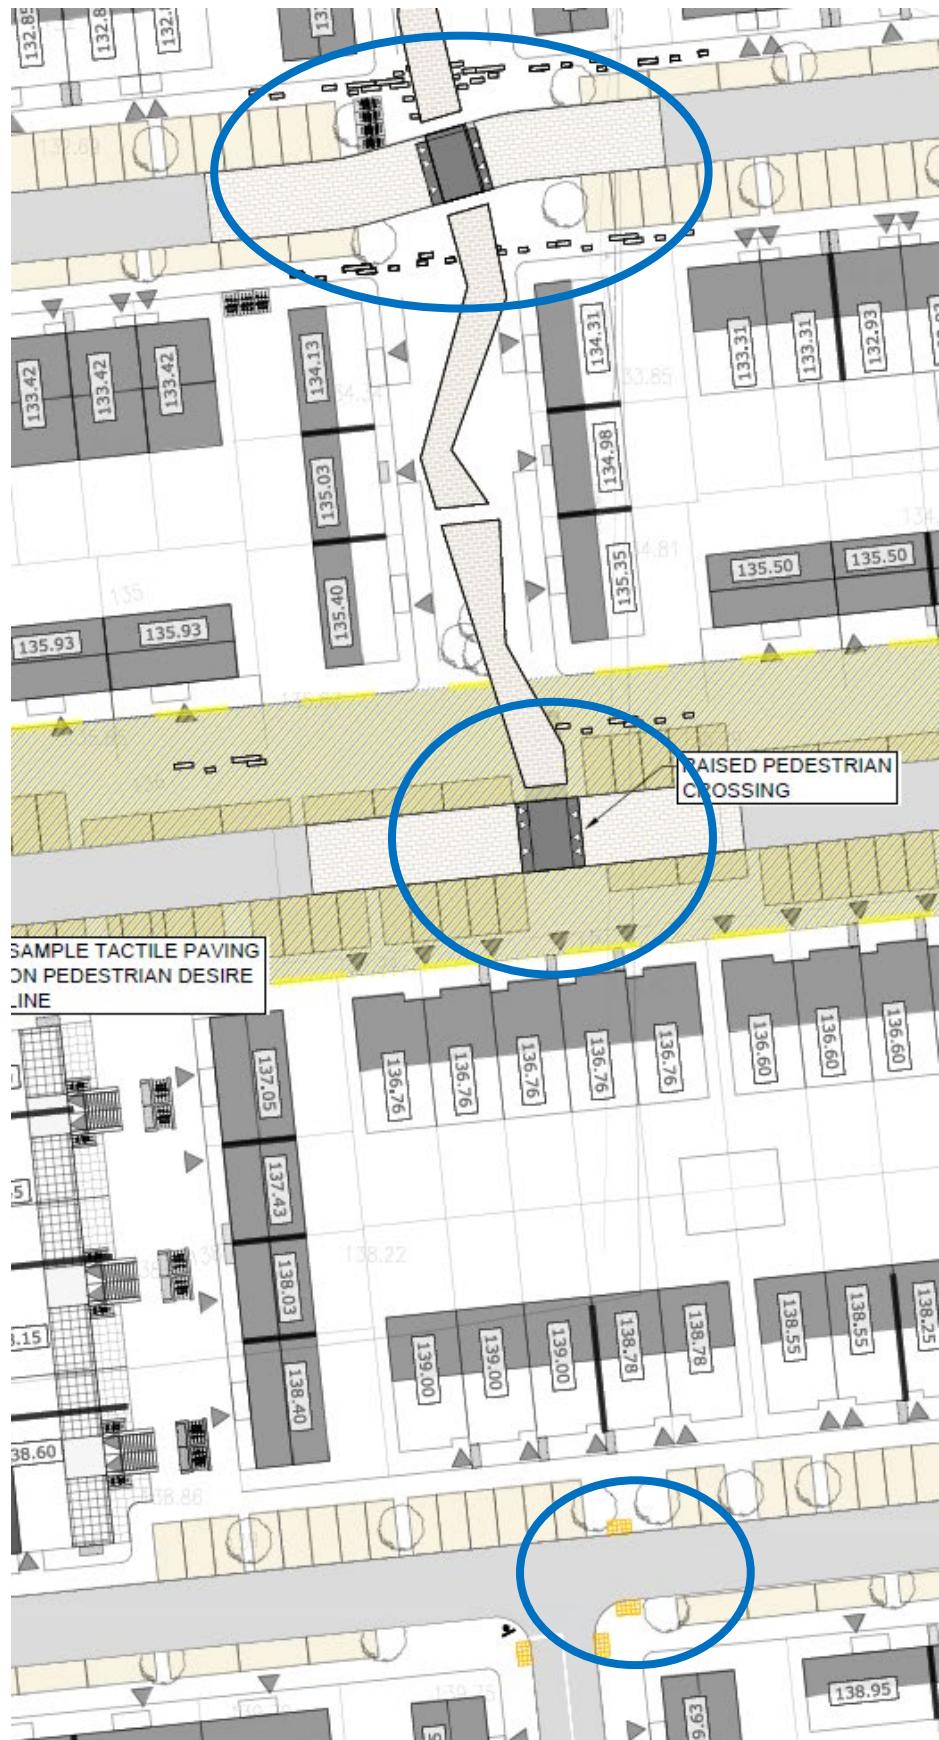
Figure 2.7 – Compromised pedestrian – Motorist Intervisibility

Location: Various

Intervisibility between pedestrians crossing pedestrian crossings and drivers of vehicles approaching the crossings may be restricted by vehicles parked in adjacent car parking spaces at a number of pedestrian crossing locations including but not limited to those shown in the image below. A lack of adequate intervisibility may contribute to a collision at these locations.

Recommendation: Ensure that adequate intervisibility is provided between pedestrians and drivers of vehicles approaching all pedestrian crossing locations.

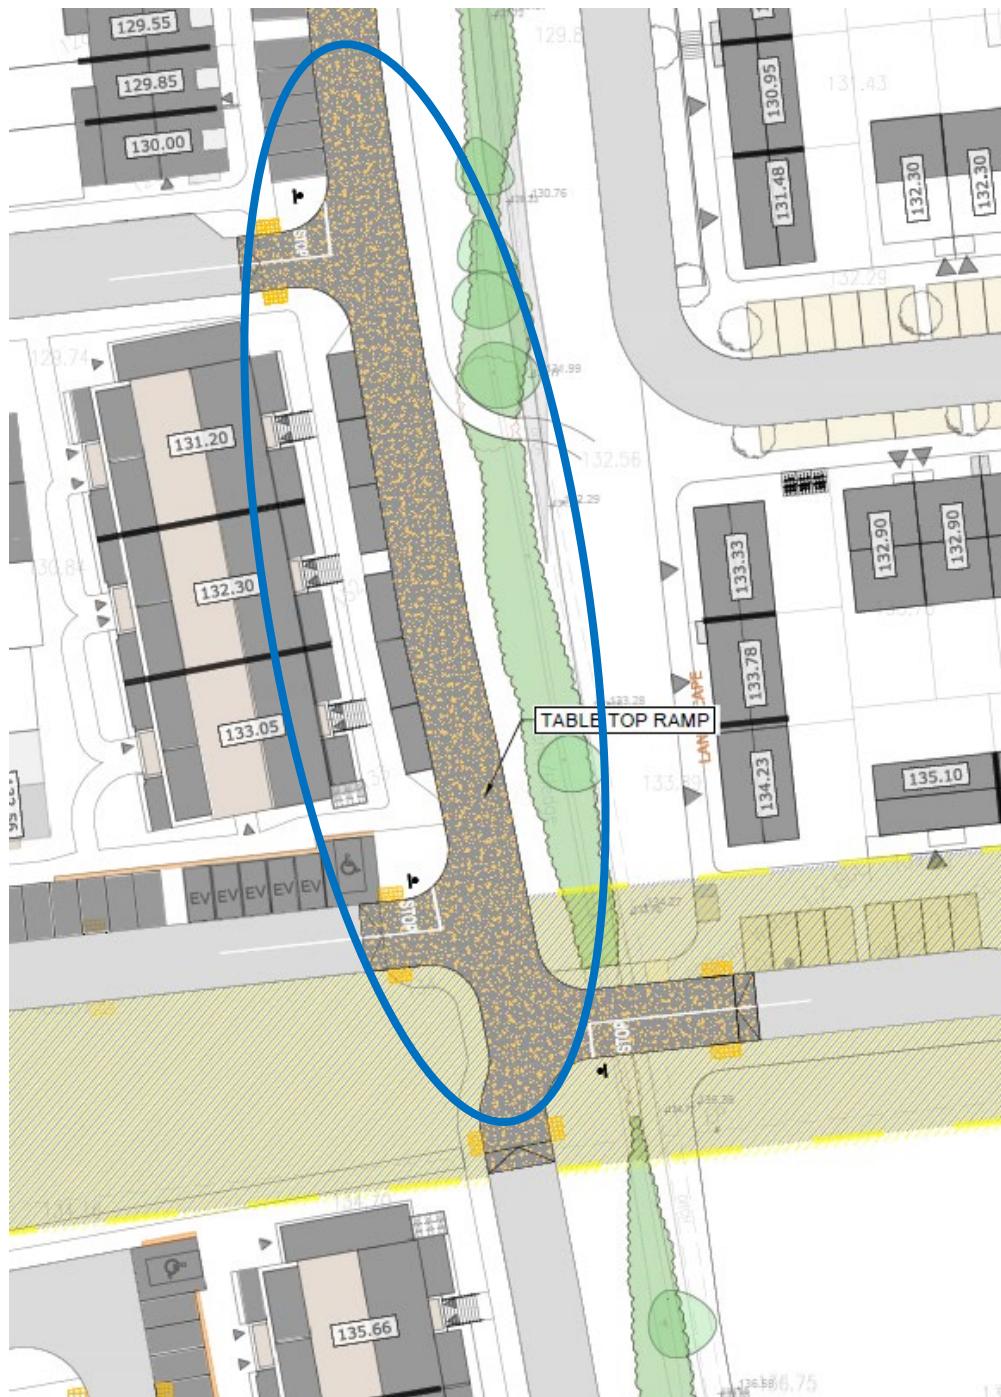
Figure 2.8 – Raise Table

Location: Various

It is unclear what, if any, grade-seperation will exist between footways and vehicular carraigeways where raised streets/tables are proposed. This may lead to navigation challenges for white cane users, who may become disoriented and wander out onto the carriageway in front of moving vehicles.

Recommendation: Ensure adequate grade separation between footways and carriageways at all locations. Alternatively, consider Tactile Paving delineators.

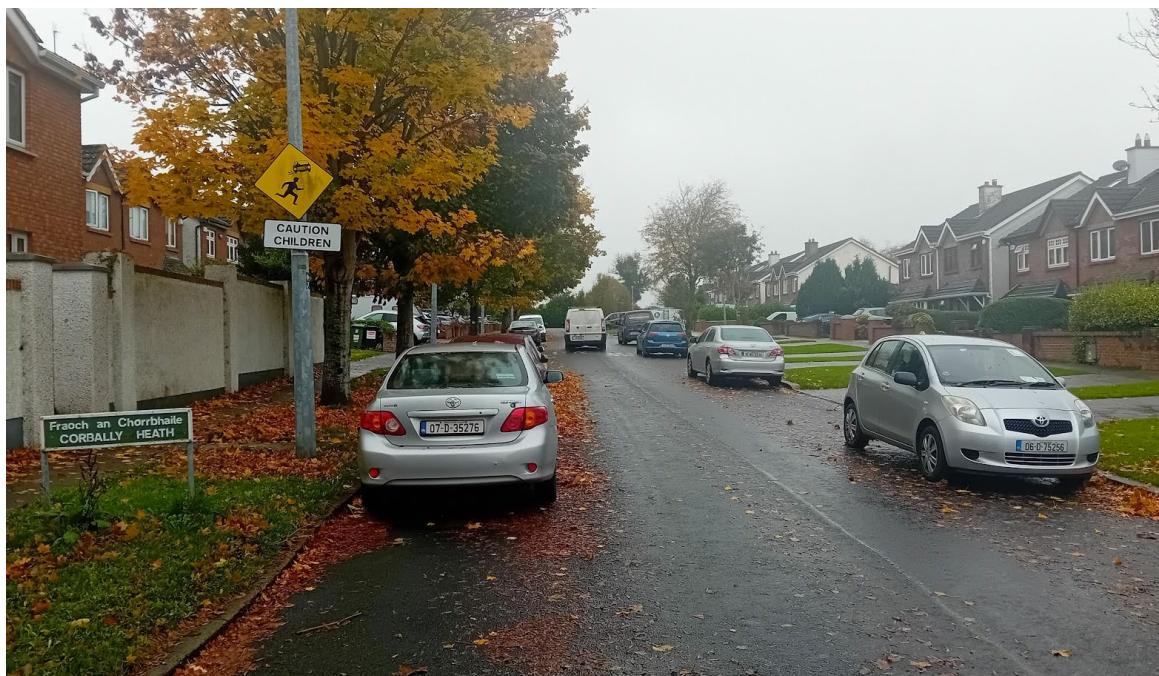
Figure 2.9 – Existing Residential Streets

2. 14 Problem: Rat Running**Location:** Existing Residential Street Network

The proposed development will open up vehicular permeability in the wider development, potentially giving rise to rat-running on the proposed and existing residential street network it ties in to, particularly for LUAS access. This may increase risk of vehicle collisions, especially with high traffic volumes, on narrow streets.

Recommendation: Restrict vehicle permeability throughout the development. Include traffic calming measures on existing streets.

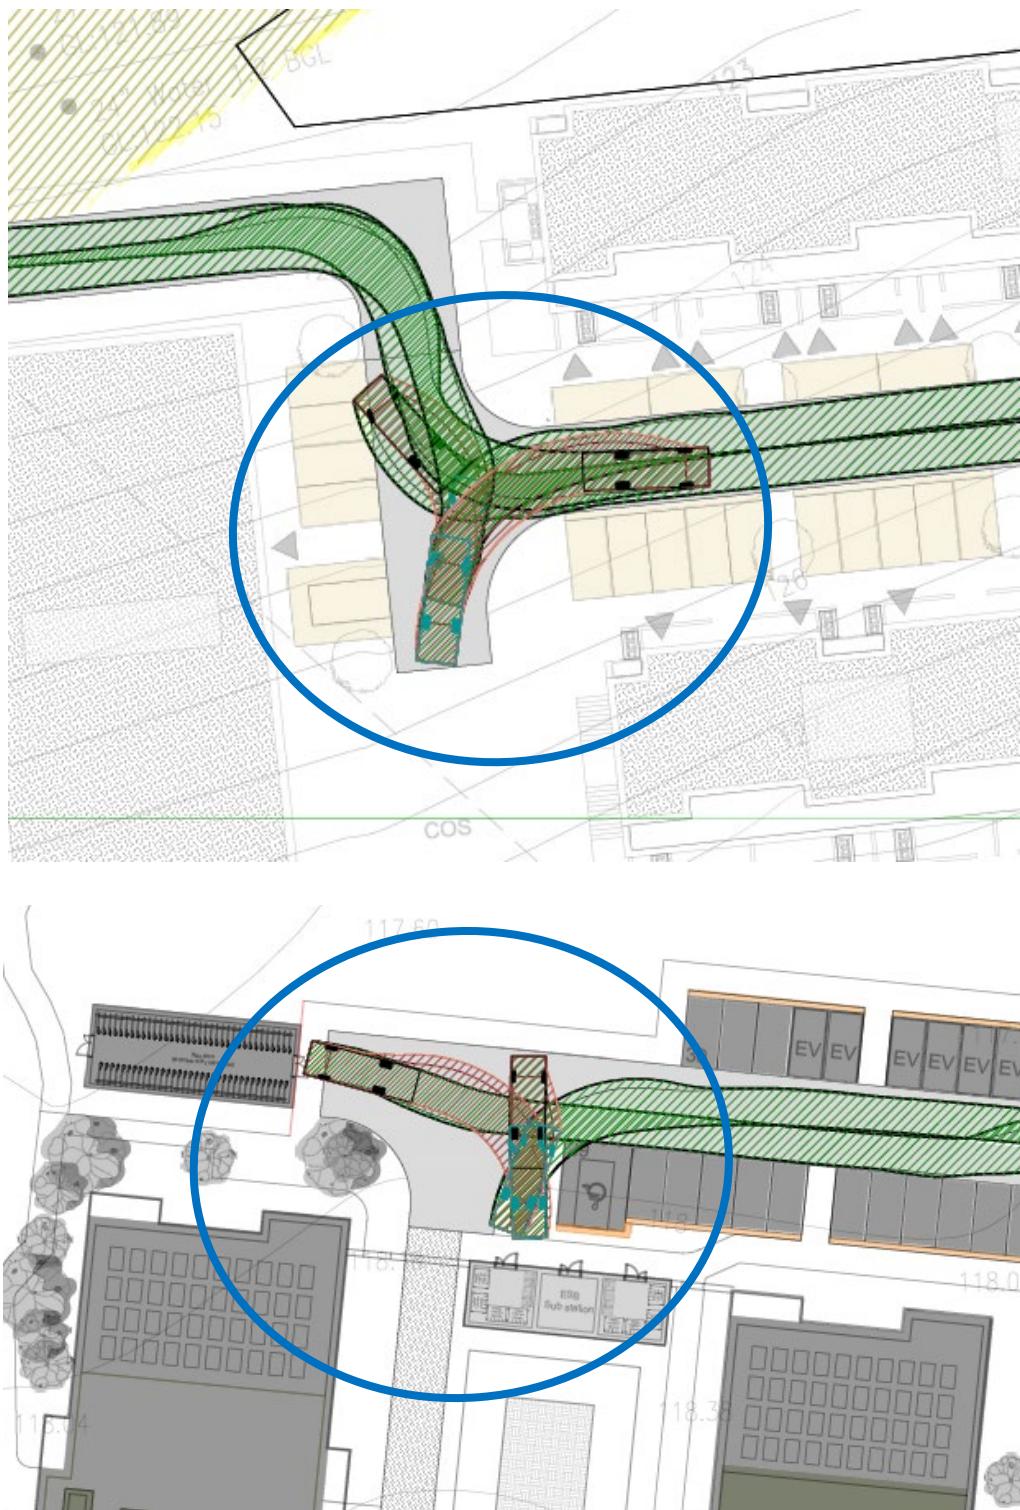
Figure 2.10 – Proposed Swept Path Analyses

Location: Existing Residential Street Network

Based on proposed Swept Path Analyses, it is unclear if all required manouevres can be completed without colliding with other vehicles or mounting footways and potentially injuring pedestrians.

Recommendation: Ensure adequate manoeuvring space. Redesign roads as required.

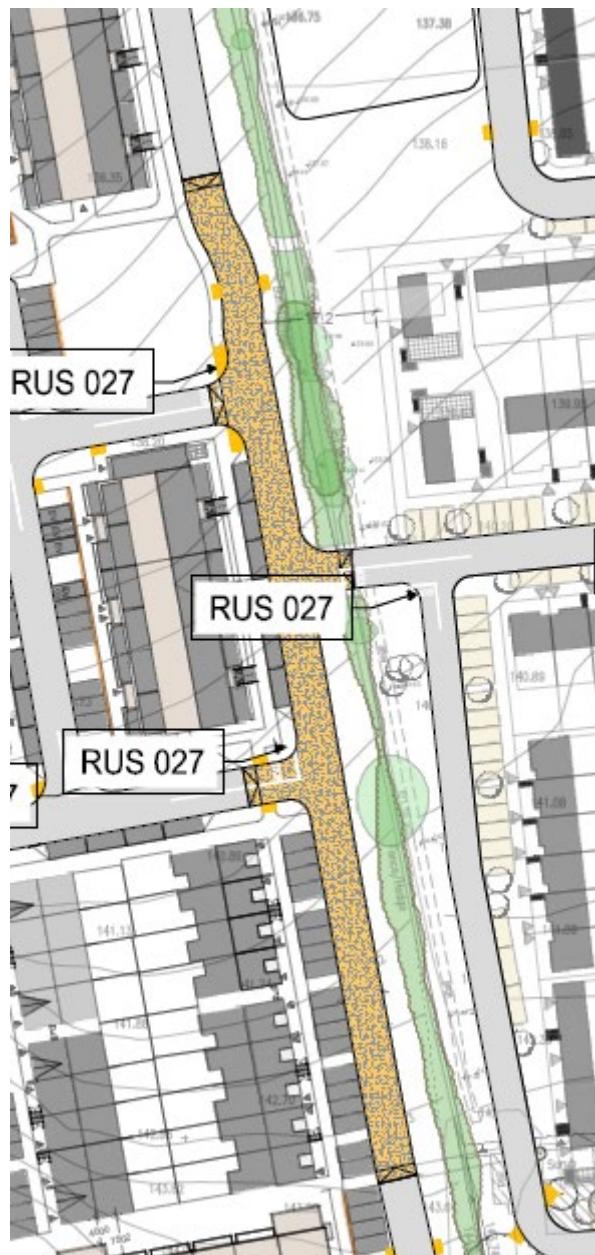
Figure 2.11 – Colour Contrast

2. 16 Problem: Colour differential between Buff Tactiles and road surfacing**Location:** Existing Residential Street Network

It is unclear what the proposed finished colour surface will be on raised carriageways. Where it is too close to buff colour tactile paving, this may cause confusion for white cane users due to the lack of colour contrast. These users may become disorientated and wander out on front of moving vehicles.

Recommendation: Ensure Adequate colour contrast between tactile paving and surrounding surfaces.

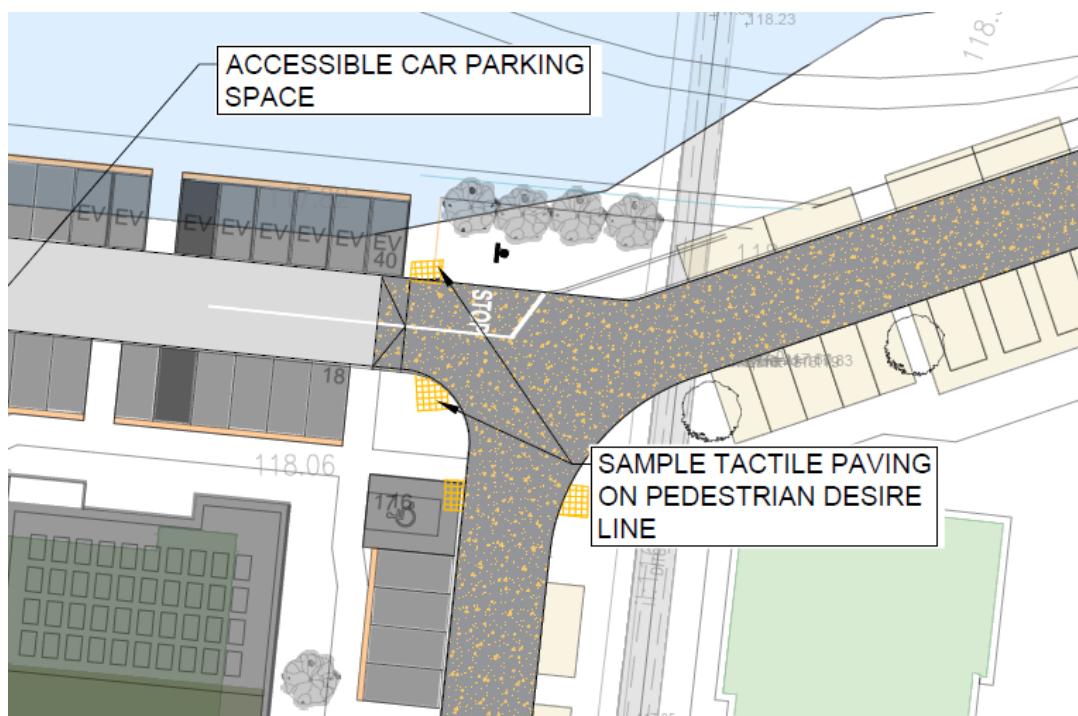
Figure 2.12 – Drainage

2.18 Problem: Drainage at Grade Transitions**Location:** Various

Various locations feature grade transitions between carriageways and raised streets/tables/crossings. It is unclear if drainage measures will be adequate and ponding of water and associated silting may result in slipping hazards for cyclists.

Recommendation: Ensure Adequate drainage that is sympathetic to the needs of cyclists.
